1ST LINE DEFENCE

Case Study

Liverpool Docks, Bootle

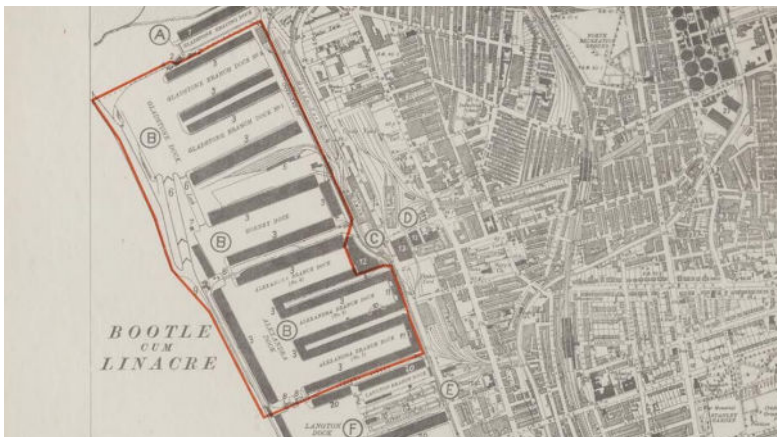
Luftwaffe target map, Liverpool Docks, 1939.

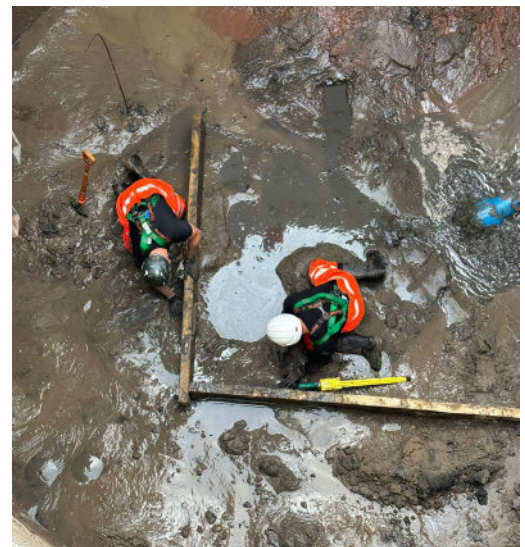
Image showing 1st Line Defence operatives excavating an anomaly inside a shaft at Liverpool Docks.

At the start of September, Target Investigation support was in place whilst excavation works proceeded on the first shaft – which was dug 6m in diameter and supported using reinforced concrete rings.

Later in September, manual excavation of the anomalies began and the first anomaly was reached at the expected depth and perfectly central to the shaft.

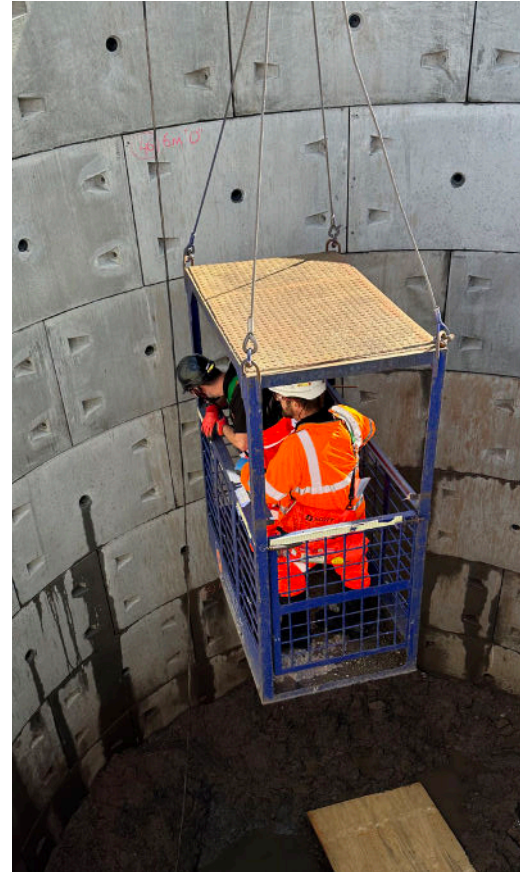
Image showing the mechanical support system in operation at Liverpool Docks.

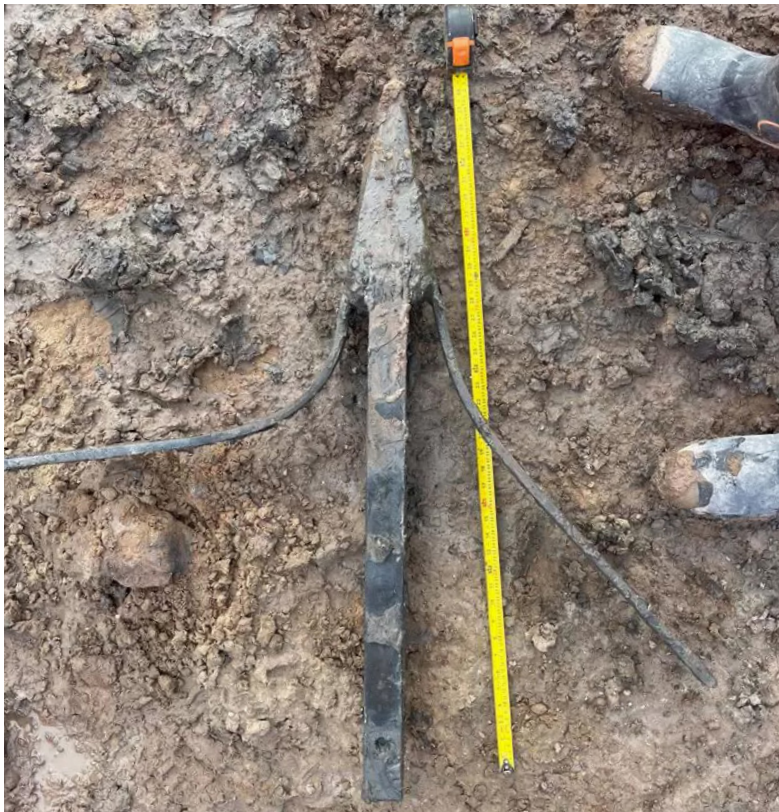
A 100m exclusion zone was set up on-site whilst the object was being excavated. After investigation, our UXO Specialists confirmed that the anomaly was not UXO-related. The anomaly was found to be a large iron rod, possible used as part of the dock construction, but deeper than would have been expected from such a remnant.

One of the anomalies found in the shafts at Liverpool Docks.

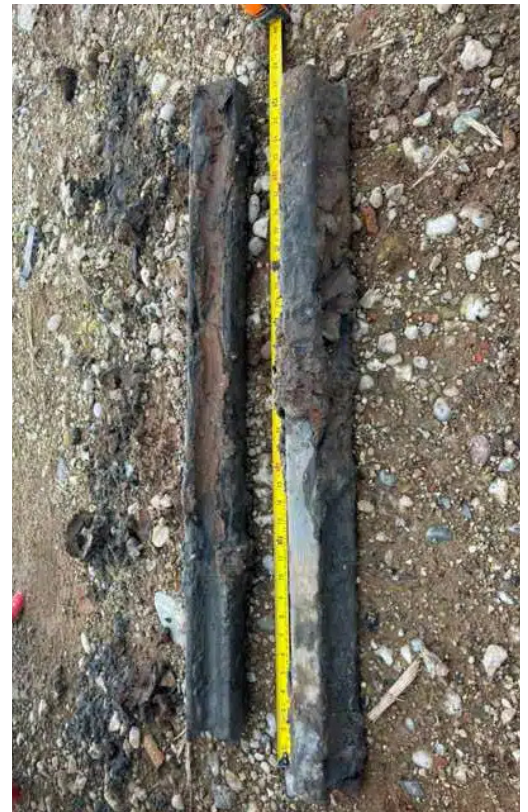
We continued with the operation and over the next two weeks, our operatives moved from shaft to shaft excavating and investigating each anomaly. All anomalies turned out to be non-UXO related, but due to their particular size and length, and the depth at which they were found, they were indistinguishable from deep buried German UXBs.

Example of some of the anomalies found in the shafts at Liverpool Docks.
